# Sun Ketch 1 Condo Association Inc Bldg 1

## Wind Mitigation Inspection Report

By: Fair Wind Inspections Inc.

| Address: 205-209 Nautilus Way | Home Phone: |

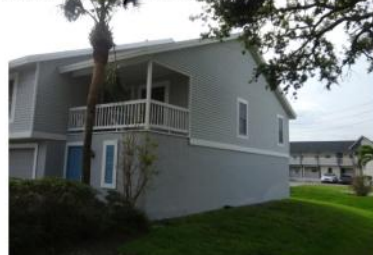
Geometry Picture

Roof Geometry: Non-Hip

Gable end walls and/or non-hip features are greater than 10% of total perimeter

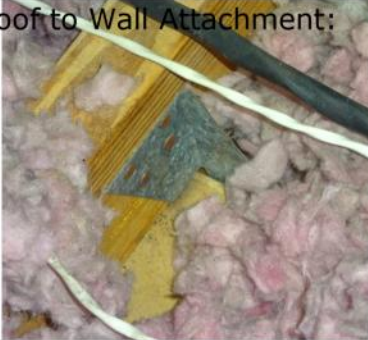
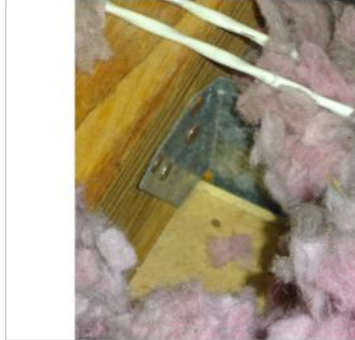
Roof to Wall Attachment:

- ☒ B. Clips
  - ☒ Metal connectors that do not wrap over the top of the truss/rafter, **or**
  - ☒ Metal connectors with a minimum of 1 strap that wraps over the top of the truss/rafter and does not meet the nail position requirements of C or D, but is secured with a minimum of 3 nails.

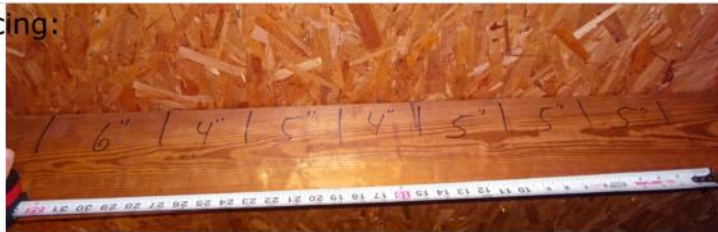
Roof Deck Thickness:

- ☒ C. Plywood/OSB roof sheathing with a minimum thickness of 7/16" inch attached to the roof truss/rafter (spaced a maximum of 24" inches o.c.) by 8d common nails spaced a maximum of 6" inches in the field. -OR- Dimensional lumber/Tongue Groove decking with a minimum of 2 nails per board (or 1 nail per board if each board is equal to or less than 6 inches in width). -OR- Any system of screws, nails, adhesives, other deck fastening system or truss/rafter spacing that is shown to have an equivalent
