# Sun Ketch 1 Condo Association Inc Bldg 10

## Wind Mitigation Inspection Report

By: Fair Wind Inspections Inc.

Date/Time: 6/2/2025 8-12  
First Name: Sun Ketch 1 Condo  
Last Name: Association Inc Bldg 10  
Contact Number:  
Contact Number:  
E-mail:  
Address: 219-229 Nautilus Way  
City: Treasure Island  
State: FL  
Zip: 33706  
County: Pinellas  
Advertiser: Previous Customer  
Referred By:

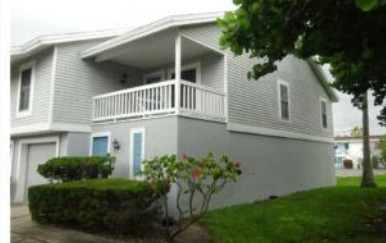
Geometry Picture

Roof Geometry: Non-Hip  
Total Non-Hip: N/A Total Perimeter: N/A  
Less Than 2:12: N/A Total Area: N/A

Gable end walls and/or non-hip features are greater than 10% of total perimeter

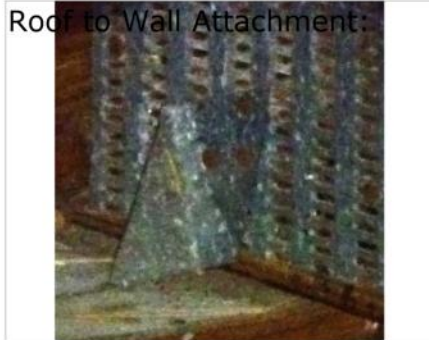
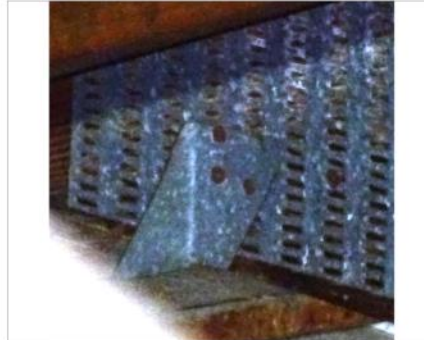
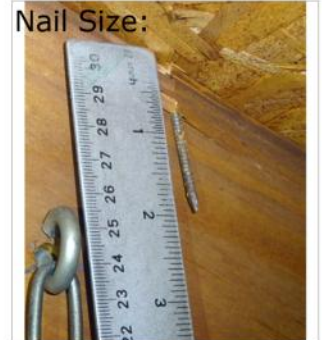
Clip Type:   
 Nails Per Clip:

- ☒ B. Clips
  - ☒ Metal connectors that do not wrap over the top of the truss/rafter, **or**
  - ☒ Metal connectors with a minimum of 1 strap that wraps over the top of the truss/rafter and does not meet the nail position requirements of C or D, but is secured with a minimum of 3 nails.

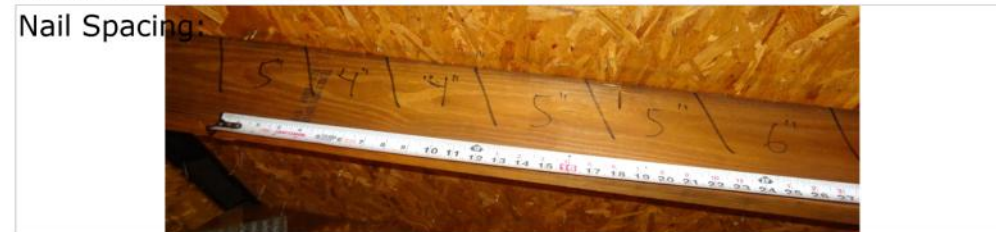
Deck Thickness:   
 Nail Size:   
 Nail Spacing:

Underside of roof is in good condition
