Sun Ketch 1 Condo Association Inc Bldg 2

Wind Mitigation Inspection Report

By: Fair Wind Inspections Inc.

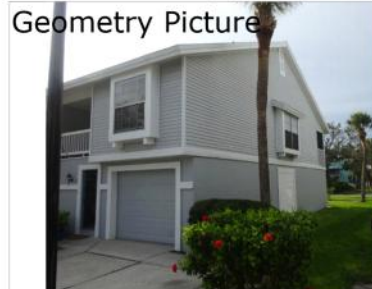
Geometry Picture

Roof Geometry: Non-Hip
Total Non-Hip: N/A Total Perimeter: N/A
Less Than 2:12: N/A Total Area: N/A

Gable end walls and/or non-hip features are greater than 10% of total perimeter

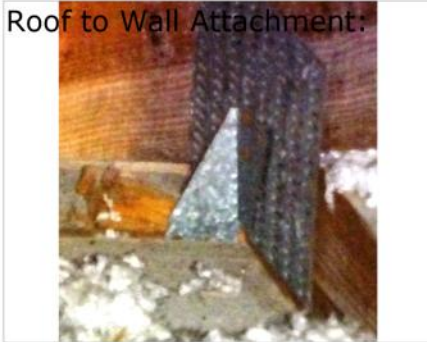
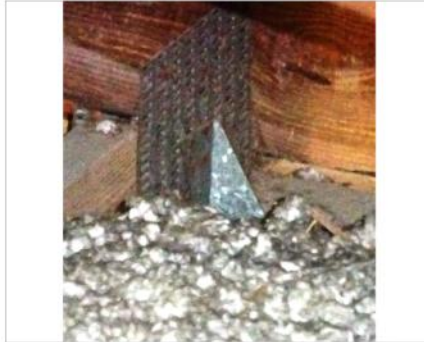
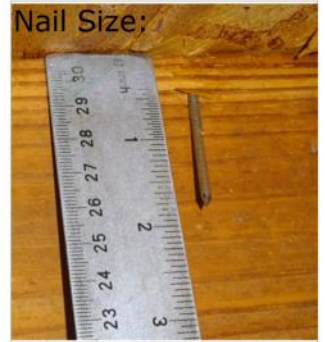
Roof to Wall Attachment:

Clip Type:
 Nails Per Clip:

- ☒ Secured to truss/rafter with a minimum of three (3) nails, **and**
- ☒ Attached to the wall top plate of the wall framing, or embedded in the bond beam, with less than a 1/2" gap from the blocking or truss/rafter and blocked no more than 1.5" of the truss/rafter, and free of visible severe corrosion.

- ☒ B. Clips
 - ☒ Metal connectors that do not wrap over the top of the truss/rafter, **or**
 - ☒ Metal connectors with a minimum of 1 strap that wraps over the top of the truss/rafter and does not meet the nail position requirements of C or D, but is secured with a minimum of 3 nails.

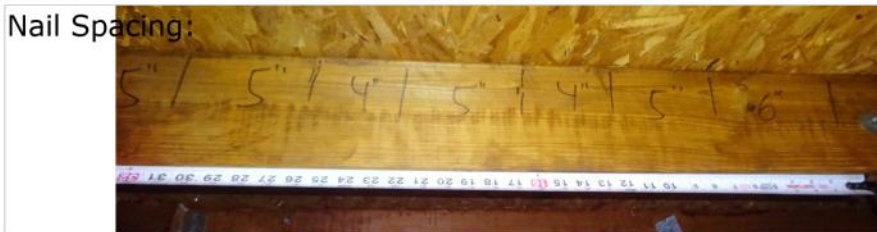
Underside of roof is in good condition

Roof Deck Thickness:

Nail Spacing:
