# Sun Ketch 1 Condo Association Inc Bldg 3

## Wind Mitigation Inspection Report

By: Fair Wind Inspections Inc.

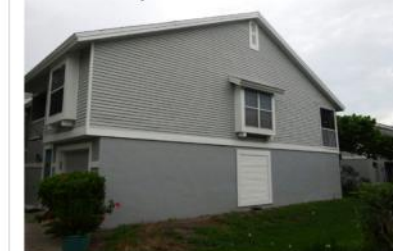
Geometry Picture

Roof Geometry: Non-Hip  
Total Non-Hip: N/A Total Perimeter: N/A  
Less Than 2:12: N/A Total Area: N/A

Gable end walls and/or non-hip features are greater than 10% of total perimeter

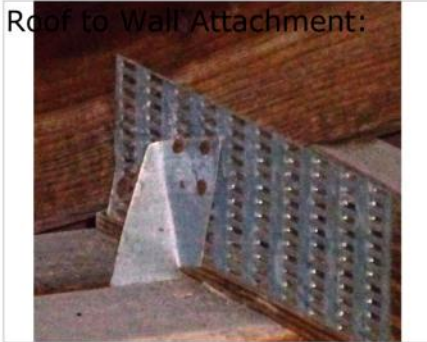
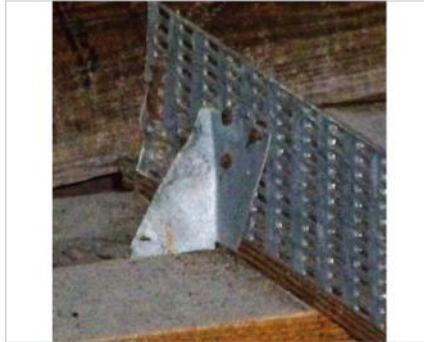
Roof to Wall Attachment:

- ☒ B. Clips
  - ☒ Metal connectors that do not wrap over the top of the truss/rafter, **or**
  - ☒ Metal connectors with a minimum of 1 strap that wraps over the top of the truss/rafter and does not meet the nail position requirements of C or D, but is secured with a minimum of 3 nails.

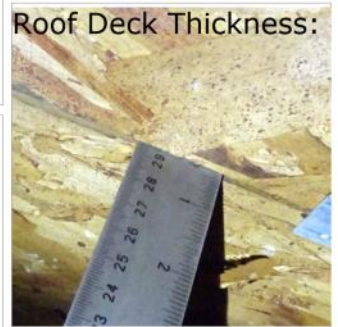
Roof Deck Thickness:

- ☒ C. Plywood/OSB roof sheathing with a minimum thickness of 7/16" inch attached to the roof truss/rafter (spaced a maximum of 24" inches o.c.) by 8d common nails spaced a maximum of 6" inches in the field. -OR- Dimensional lumber/Tongue Groove decking with a minimum of 2 nails per board (or 1 nail per board if each board is equal to or less than 6 inches in width). -OR- Any system of screws, nails, adhesives, other deck fastening system or truss/rafter spacing that is shown to have an equivalent
