# Sun Ketch 1 Condo Association Inc Bldg 5

## Wind Mitigation Inspection Report

By: Fair Wind Inspections Inc.

Date/Time: 6/2/2025 8-12  
First Name: Sun Ketch 1 Condo  
Last Name: Association Inc Bldg 5  
Contact Number:  
Contact Number:  
E-mail:  
Address: 238-248 Nautilus Way  
City: Treasure Island  
State: FL  
Zip: 33706  
County: Pinellas  
Advertiser: Previous Customer  
Referred By:

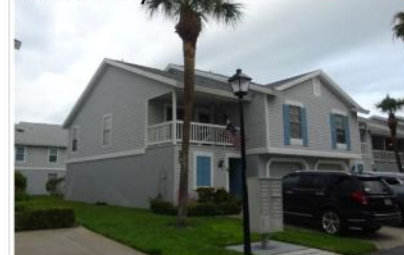
Geometry Picture

Roof Geometry: Non-Hip

Gable end walls and/or non-hip features are greater than 10% of total perimeter

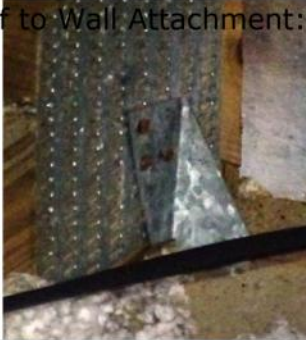
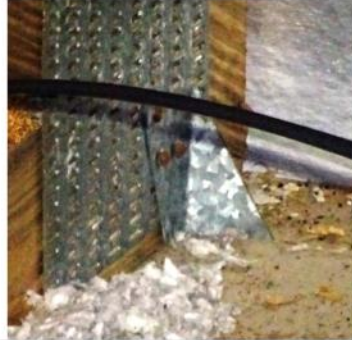
Roof to Wall Attachment:

- ☒ B. Clips
  - ☒ Metal connectors that do not wrap over the top of the truss/rafter, **or**
  - ☒ Metal connectors with a minimum of 1 strap that wraps over the top of the truss/rafter and does not meet the nail position requirements of C or D, but is secured with a minimum of 3 nails.

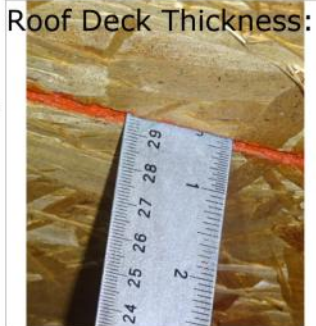
Roof Deck Thickness:

- ☒ C. Plywood/OSB roof sheathing with a minimum thickness of 7/16" inch attached to the roof truss/rafter (spaced a maximum of 24" inches o.c.) by 8d common nails spaced a maximum of 6" inches in the field. -OR- Dimensional lumber/Tongue Groove decking with a minimum of 2 nails per board (or 1 nail per board if each board is equal to or less than 6 inches in width). -OR- Any system of screws, nails, adhesives, other deck fastening system or truss/rafter spacing that is shown to have an equivalent
