# Sun Ketch 1 Condo Association Inc Bldg 7

## Wind Mitigation Inspection Report

By: Fair Wind Inspections Inc.

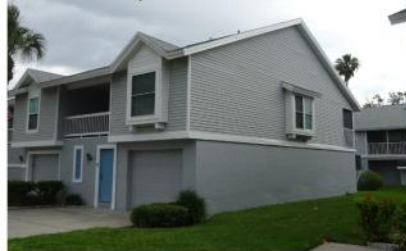
Geometry Picture

Roof Geometry: Non-Hip  
Total Non-Hip: N/A Total Perimeter: N/A  
Less Than 2:12: N/A Total Area: N/A

Gable end walls and/or non-hip features are greater than 10% of total perimeter

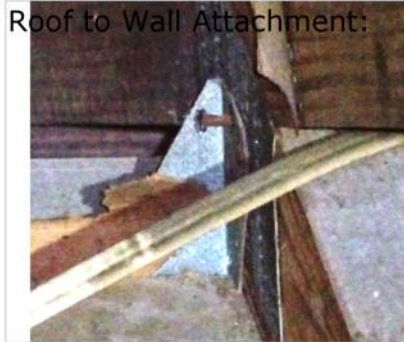
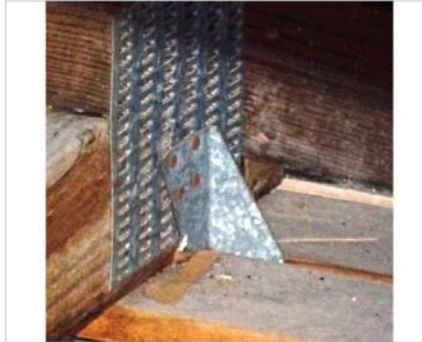
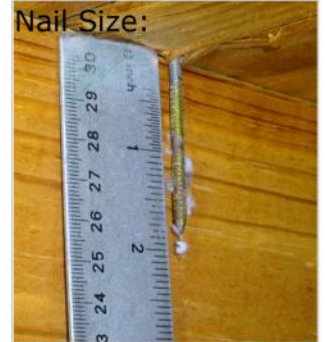
Clip Type:   
 Nails Per Clip:

- ☒ B. Clips
  - ☒ Metal connectors that do not wrap over the top of the truss/rafter, **or**
  - ☒ Metal connectors with a minimum of 1 strap that wraps over the top of the truss/rafter and does not meet the nail position requirements of C or D, but is secured with a minimum of 3 nails.

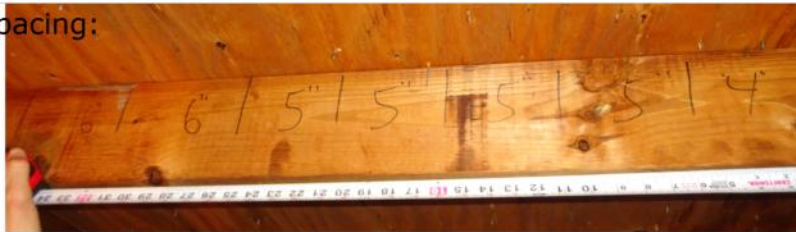
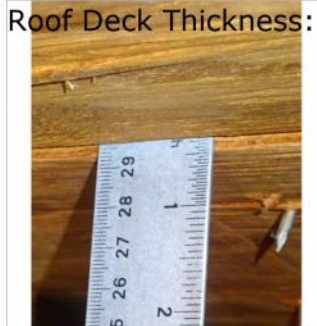
Roof Deck Thickness:

Underside of roof is in good condition

- ☒ C. Plywood/OSB roof sheathing with a minimum thickness of 7/16" inch attached to the roof truss/rafter (spaced a maximum of 24" inches o.c.) by 8d common nails spaced a maximum of 6" inches in the field. -OR- Dimensional lumber/Tongue Groove decking with a minimum of 2 nails per board (or 1 nail per board if each board is equal to or less than 6 inches in width). -OR- Any system of screws, nails, adhesives, other deck fastening system or truss/rafter spacing that is shown to have an equivalent
