# Sun Ketch 1 Condo Association Inc Bldg 8

## Wind Mitigation Inspection Report

Date/Time: 6/2/2025 8-12  
First Name: Sun Ketch 1 Condo  
Last Name: Association Inc Bldg 8  
Contact Number:  
Contact Number:  
E-mail:  
Address: 250-254 Sea Mist Dr  
City: Treasure Island  
State: FL  
Zip: 33706  
County: Pinellas  
Advertiser: Previous Customer  
Referred By:

Year Built: 1986  
Square Foot:  
Evacuation Zone: A  
Distance from Bay/Gulf: On Intercoastal  
Exposure Category: B  
Stories: 2  
Inspected By: Kevin  
Price: 80  
Home Notes:

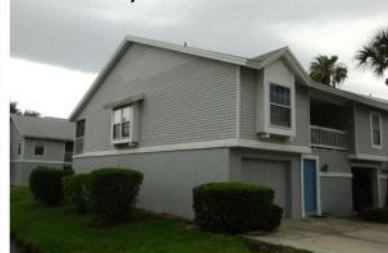
Geometry Picture

Roof Geometry: Non-Hip

Gable end walls and/or non-hip features are greater than 10% of total perimeter

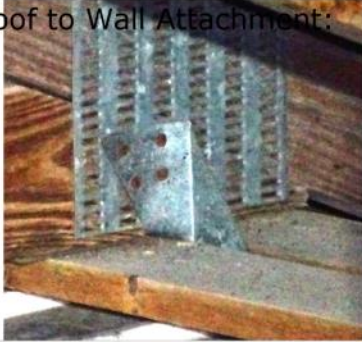
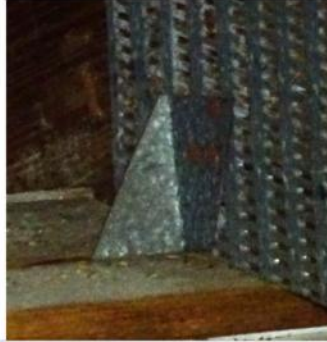
Roof to Wall Attachment:

- ☒ B. Clips
  - ☒ Metal connectors that do not wrap over the top of the truss/rafter, **or**
  - ☒ Metal connectors with a minimum of 1 strap that wraps over the top of the truss/rafter and does not meet the nail position requirements of C or D, but is secured with a minimum of 3 nails.

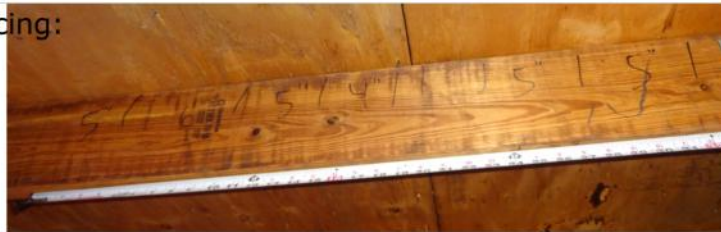
Nail Spacing:

Underside of roof is in good condition

- ☒ C. Plywood/OSB roof sheathing with a minimum thickness of 7/16" inch attached to the roof truss/rafter (spaced a maximum of 24" inches o.c.) by 8d common nails spaced a maximum of 6" inches in the field. -OR- Dimensional lumber/Tongue Groove decking with a minimum of 2 nails per board (or 1 nail per board if each board is equal to or less than 6 inches in width). -OR- Any system of screws, nails, adhesives, other deck fastening system or truss/rafter spacing that is shown to have an equivalent
